## **Eastern Brook Trout Joint Venture Completed Project Report Form**

**Project Title: EBTJV/NFHAP Carloe Brook ME Fish Passage Restoration**

- **Location:** T27ED BPP Washington County, Maine

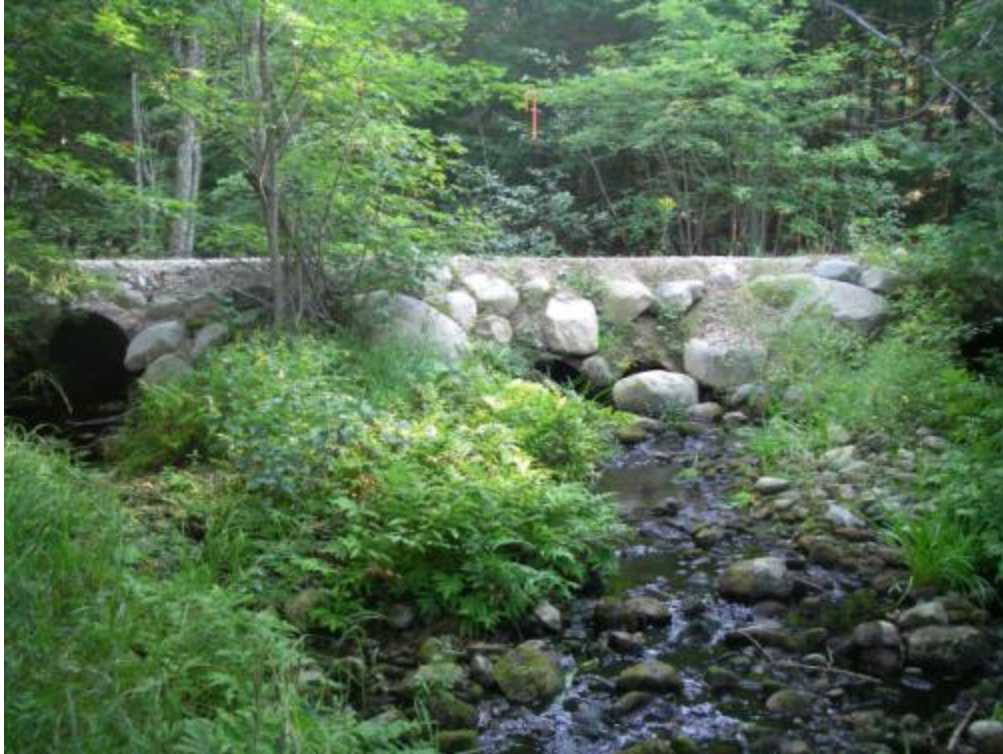
The project replaced an undersized and failing stream crossing on Carloe Brook a major tributary to Clifford Lake that has wild brook trout. This stream crossing currently limits passage for trout and other aquatic organisms. The current crossing is also a significant sediment source do to improper construction and overtopping. The crossing will be replaced with a 1.2 bankfull open bottom arch culvert (15ft wide) designed to allow passage at all flows.

**Looking upstream to Old Culverts (n=5).**

New crossing was designed using stream simulation techniques to ensure proper sizing and placement of the new structure. A 1.2 x bankfull width open bottom arch culvert replaced 5 undersized and damaged round culverts.

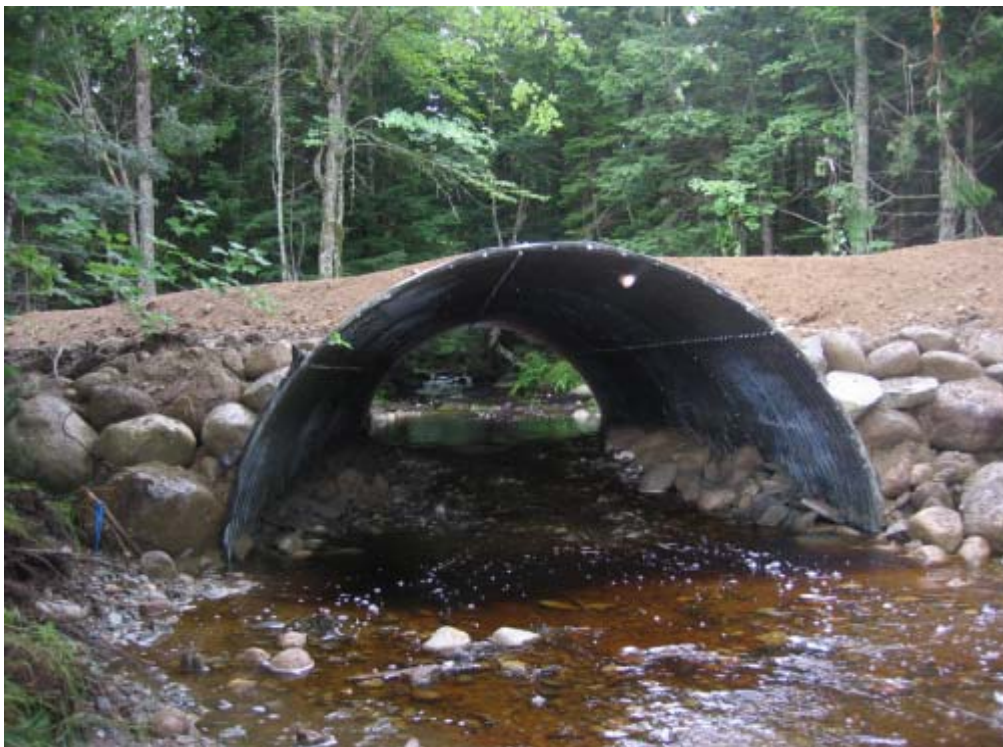
**Looking upstream to new 15 ft wide Open Arch. Aug 12, 2011**

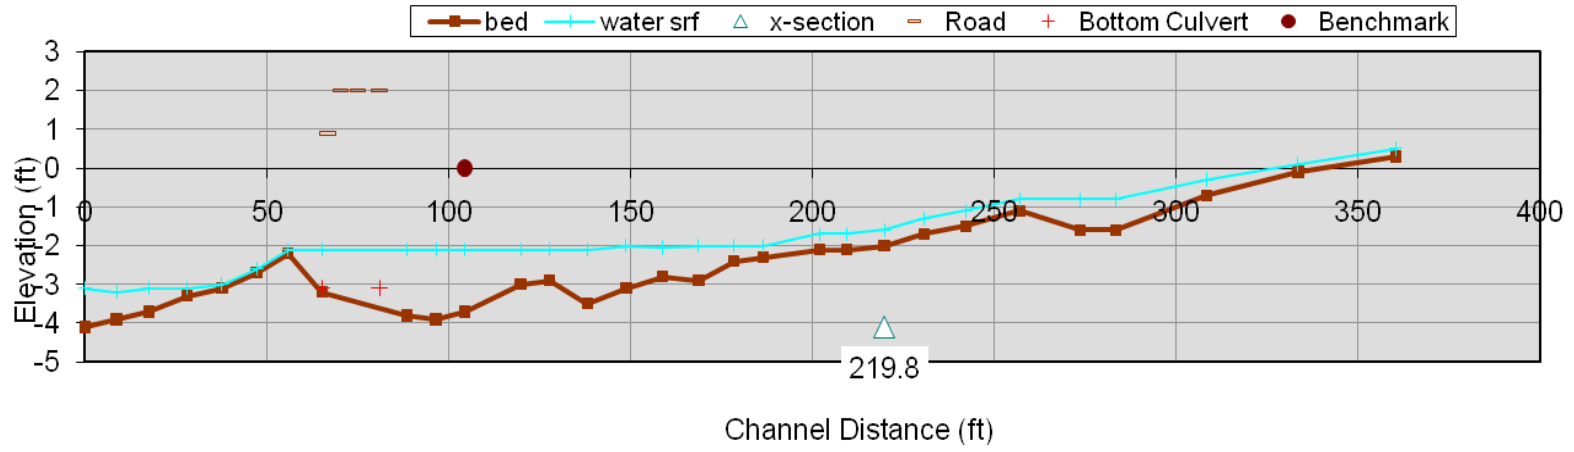
Longitudinal Profile- Pre Project.
