Eastern Brook Trout Joint Venture

Final Project Report

Rehabilitation of an Unnamed sea-run brook trout stream, Belfast, Maine

Project Sponsor: Maine Department of Inland Fisheries and Wildlife

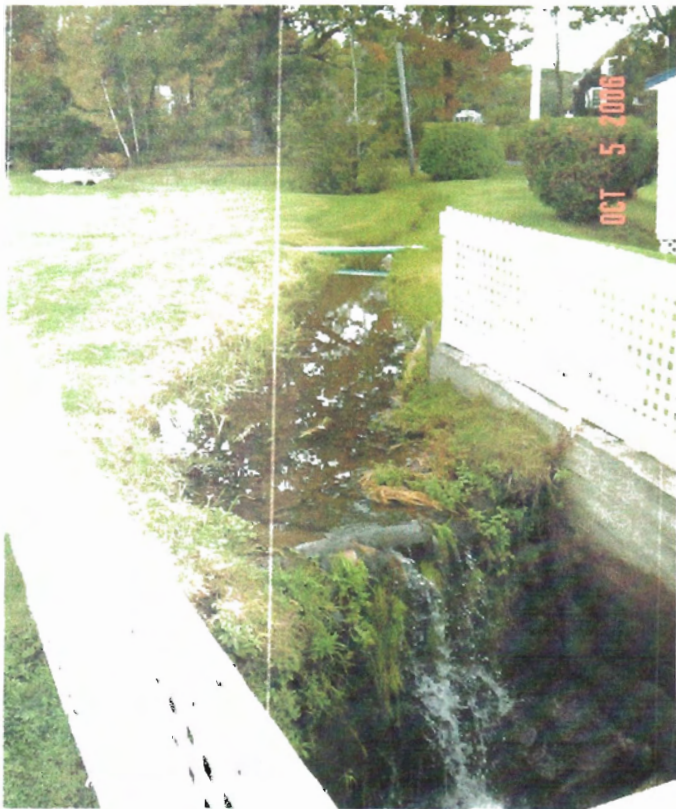
Belfast, Maine: Unnamed Stream, existing dam and view of stream channel.  
Photograph: W. L. Woodward, Oct, 5, 2006.

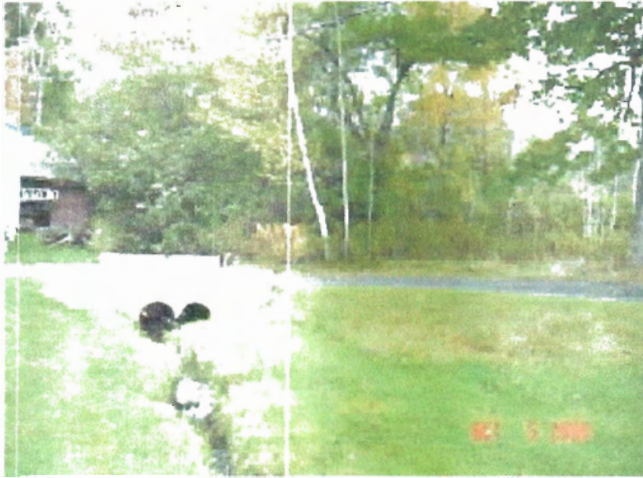
Belfast, Maine: Unnamed Stream, existing culverts (upstream of dam).  
Photograph: W.L. Woodward, Oct. 5, 2006

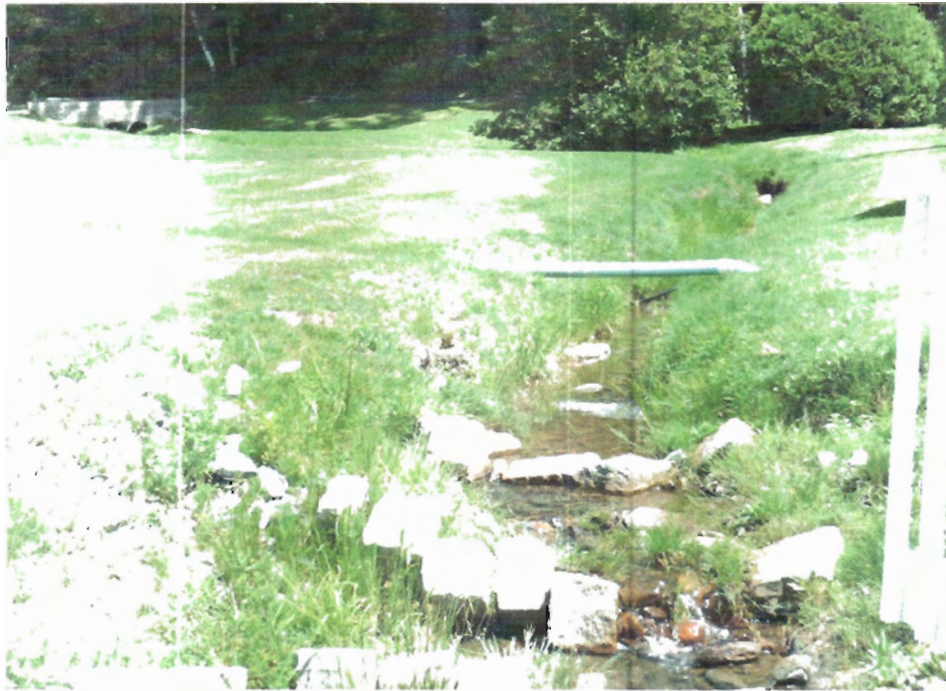
2011: View is of upstream from the twin 18" culverts, Sta. 0+0.  
Photograph: R. Van Riper, July 2011

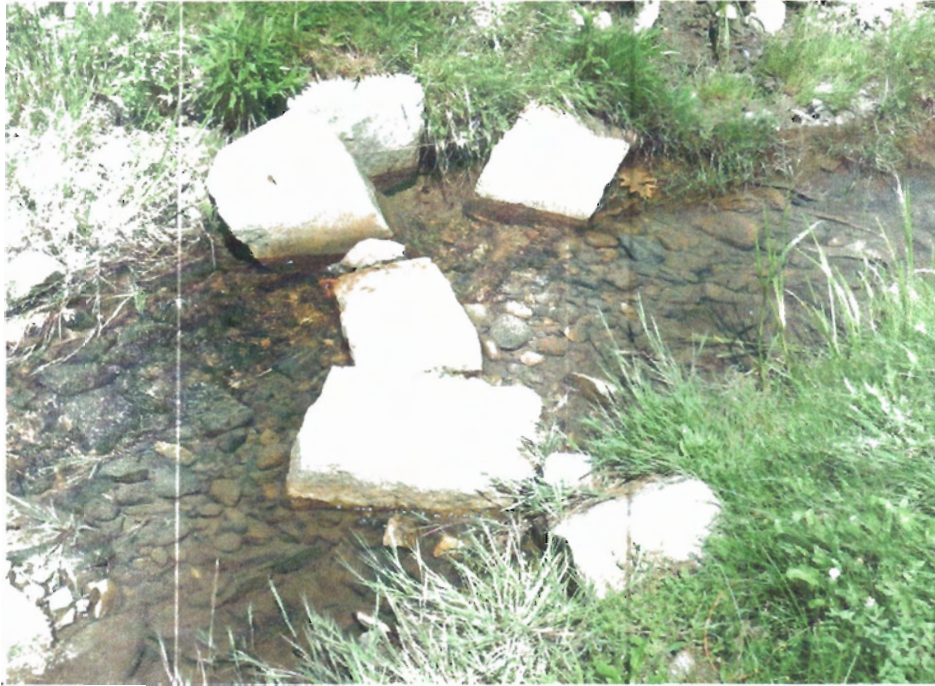
In spring 2010, large discharge volumes generated by snowmelt exceeded bankfull of the stream and eroded portions of the structures located at 0+15, 0+24 and 0+32. Some of the embedded blocks were exposed to varying depths. All structures remained where they were built. In short, the stream adjusted its horizontal channel position in response to the changes in vertical corrections put in place by the project. Subsequent large discharge volumes resulting from either snowmelt or precipitation have not caused additional rearrangement of the structures. Ultimately, the project has resulted in a situation where natural processes are again controlling channel development and connectivity for fish movements have been restored.

2011: View at Sta. 0 + 20.  
Photograph: R. Van Riper, July 2011

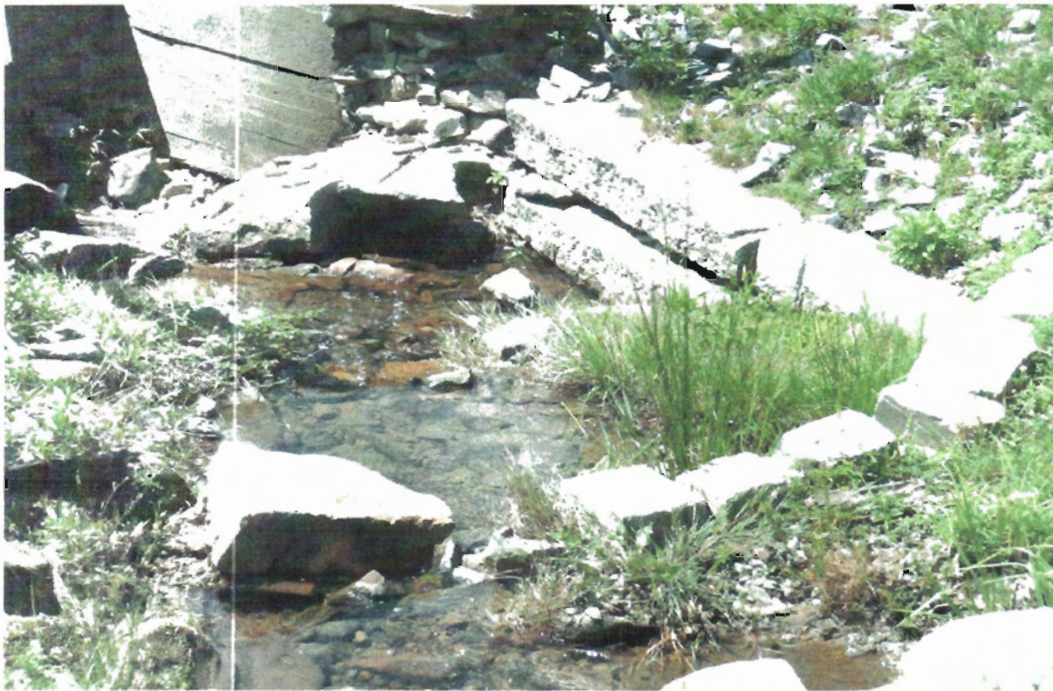
2011: View downstream from Sta. 0+10  
Photograph: R. Van Riper, July 2011

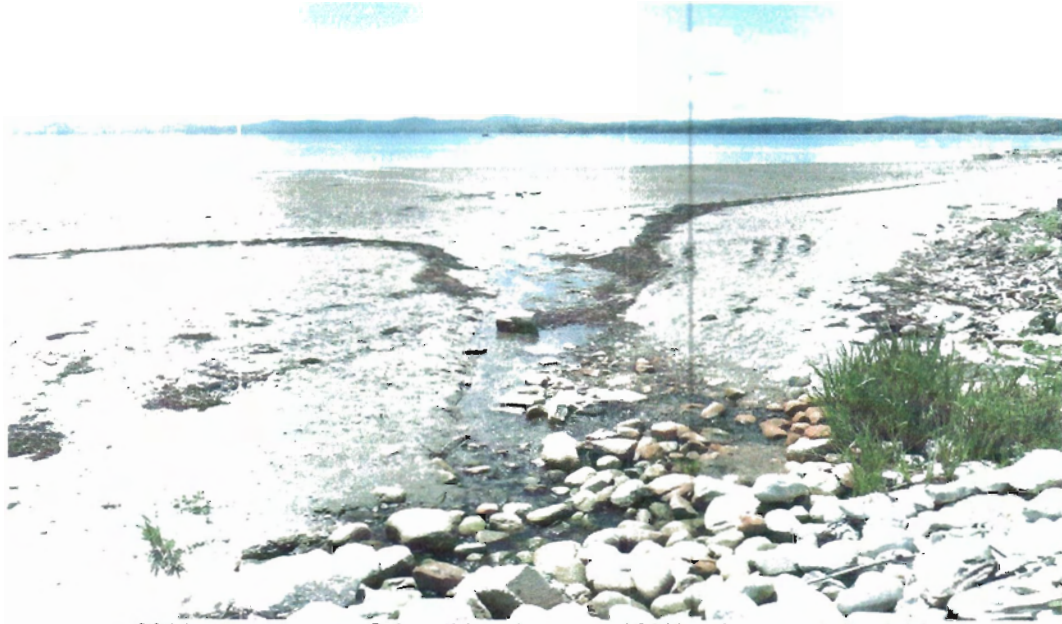
2011: downstream @ low tide, pipes are 100% submerged @ MHW  
Photograph: R. Van Riper, July 2011

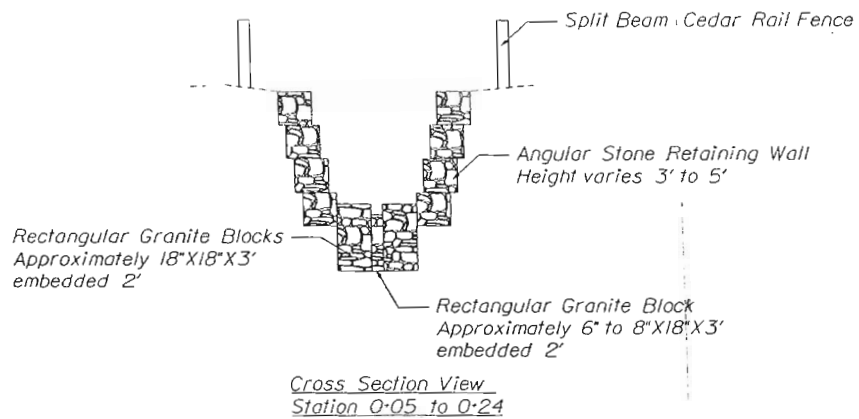
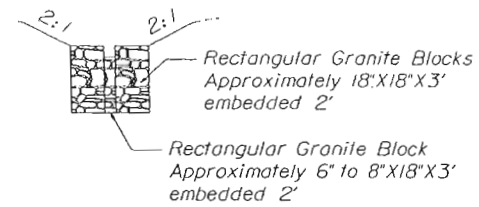
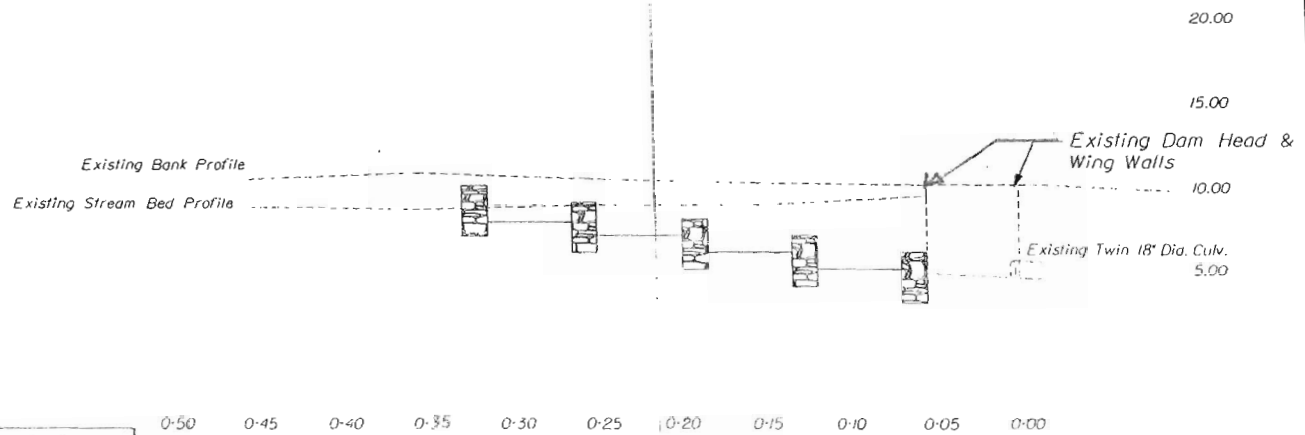
Profile View

The drop structures used to correct the vertical alignment after removal are located at Sta. 0+7, 0+15, 0+24, and 0+32. With the exception of the structure at Sta. 0+7, which used native cobble and boulder, the drop structures were built utilizing cut granite blocks roughly measuring 8" X 12" X 36". The structures were constructed as shown on the attached cross-sectional view on the attached plan.
