Eastern Brook Trout Joint Venture Completed Project Report Form

Project Title: EBTJV/NFHAP Carloe Brook ME Fish Passage Restoration

- **Location:** T27ED BPP Washington County, Maine

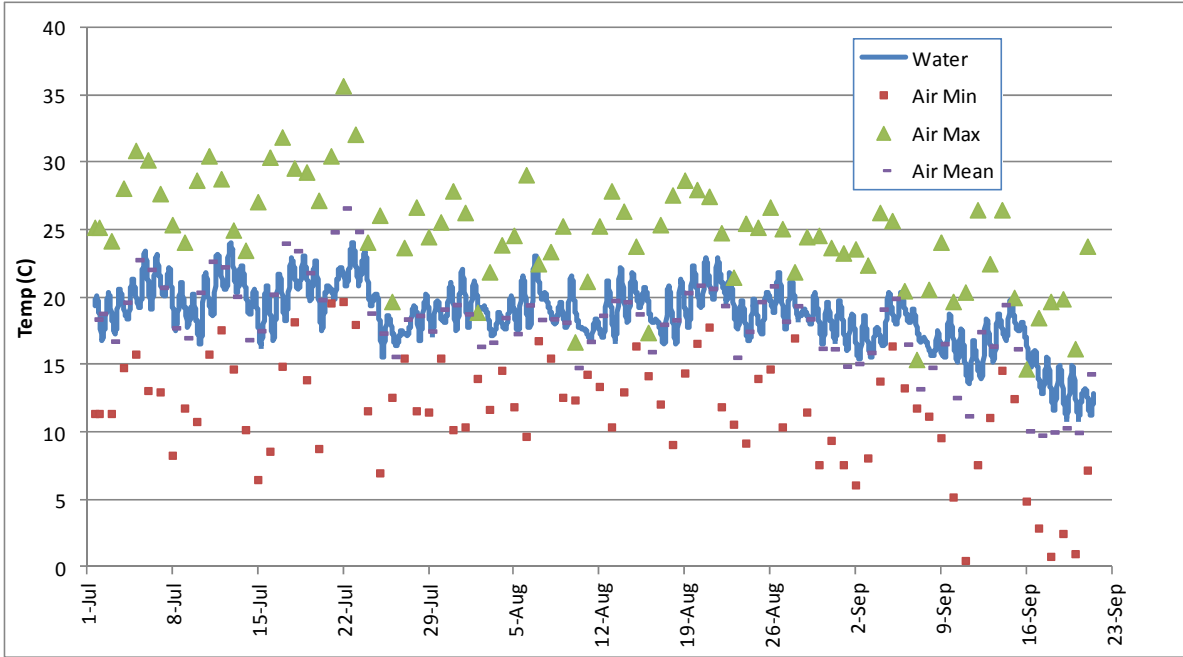
Water Temperature of Carloe Brook (above road) in summer 2011.

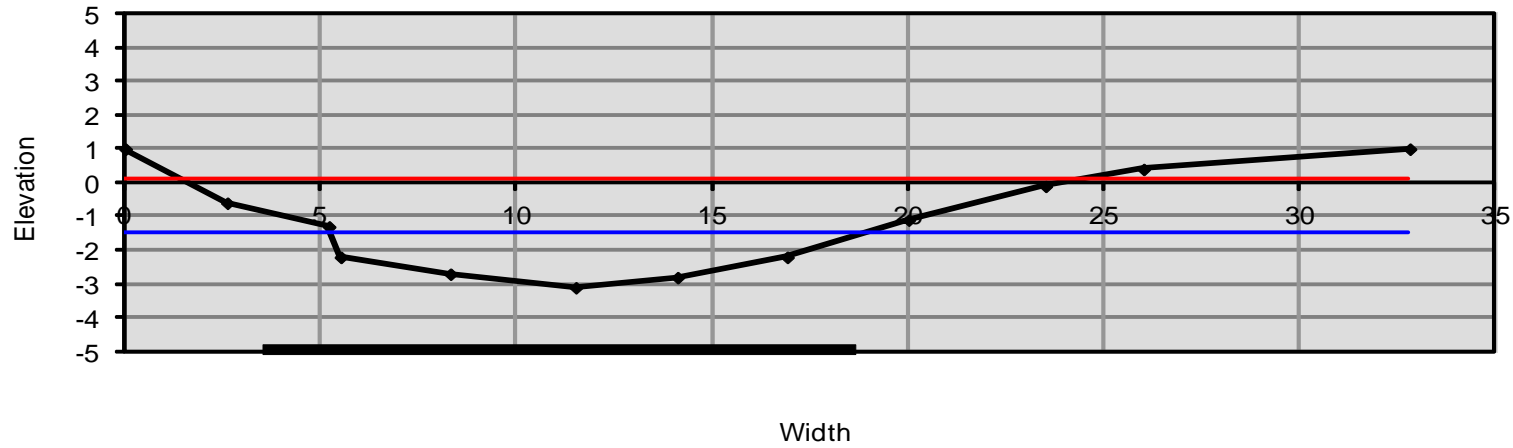
- 14.5 ▾ x-section area (ft.sq.)
- 13.6 ▾ width (ft)
- 1.1 ▾ mean depth (ft)
- 1.6 ▾ max depth (ft)
- 14.4 ▾ wetted parimeter (ft)
- 1.0 ▾ hyd radi (ft)
- 12.8 ▾ width-depth ratio

- 23.0 ▾ W flood prone area (ft)
- 1.7 ▾ entrenchment ratio
- ▾ low bank height (ft)
- ▾ low bank height ratio

Channel cross section at location 219.8ft (Reference Area). Blue line= Bankfull, Red Line Flood Prone Elevation
