Connecticut River Aquatic Habitat Connectivity

Fish Passage in the White River Watershed

Nason Brook at the Woodlawn Cemetery, Rochester Vermont

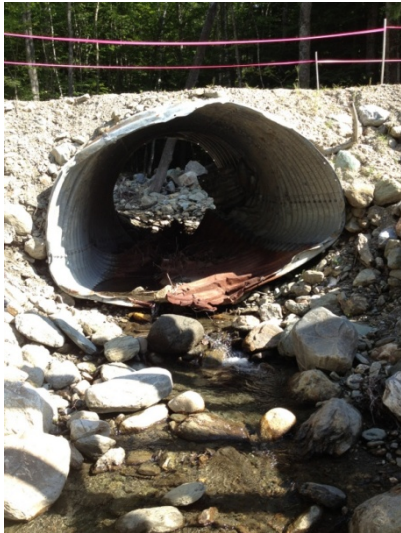
Before

Left: A view of the Nason Brook culvert outlet showing the damage from TS Irene. **Right:** Nason Brook Bridge allowing for aquatic organism passage and flood resiliency.

Problems / history: Multiple culverts in Vermont were in need of emergency repair following the flooding from tropical storm Irene in August of 2011. Following tropical storm Irene many of the emergency fixes were designed to quickly open roads for vehicle traffic, but not always allow for fish and aquatic organism passage. Working closely with FEMA and the town of Rochester the US Fish and Wildlife Service has provided technical assistance, engineering designs, and project over site to ensure projects allow both fish and aquatic organism passage.

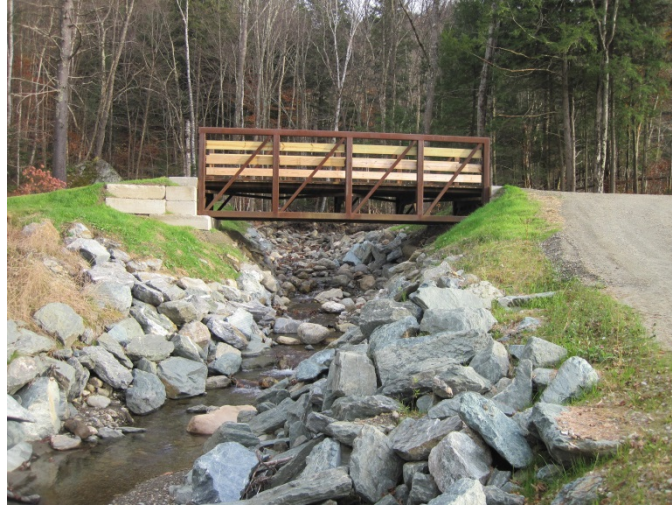
After

Site description: Nason Brook in Rochester Vermont is a headwater tributary to the White River and supports a thriving fishery including Atlantic salmon and a wild brook trout population. This new bridge allows native brook trout to access 4 miles of critical thermal refugia and spawning habitat.
