Connecticut River Aquatic Habitat Connectivity

Fish Passage in the White River Watershed

Marsh Brook on Marsh Brook Rd Road, Rochester Vermont

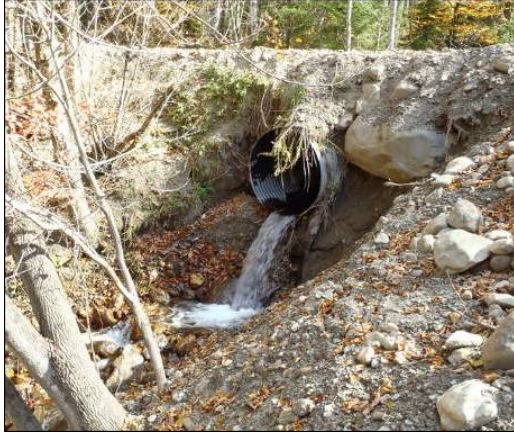
Before

Left: A view of the Nason Brook culvert outlet at Moose Run road showing the emergency replacement culvert with zero fish or aquatic organism passage. **Right:** Nason Brook Bridge at Moose Run road allowing for aquatic organism passage and flood resiliency.

Problems / history: Multiple culverts in Rochester Vermont were in need of emergency repair following the flooding from tropical storm Irene in August of 2011. Following tropical storm Irene many of the emergency fixes were designed to quickly open roads for vehicle traffic, but not always allow for fish and aquatic organism passage. Working closely with FEMA and the town of Rochester the US Fish and Wildlife Service has provided technical assistance, engineering designs, and project over site to ensure projects allow both fish and aquatic organism passage.

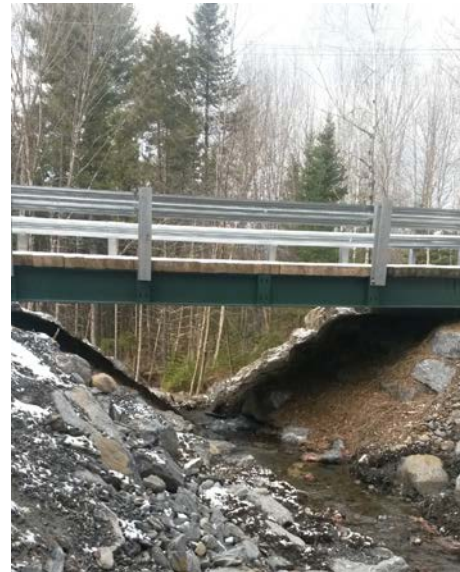
After

Site description: Nason Brook in Rochester Vermont is a headwater tributary to the White River and supports a thriving fishery including Atlantic salmon and a wild brook trout population. This new bridge allows native brook trout to access 1.1 miles of critical thermal refugia and spawning habitat.

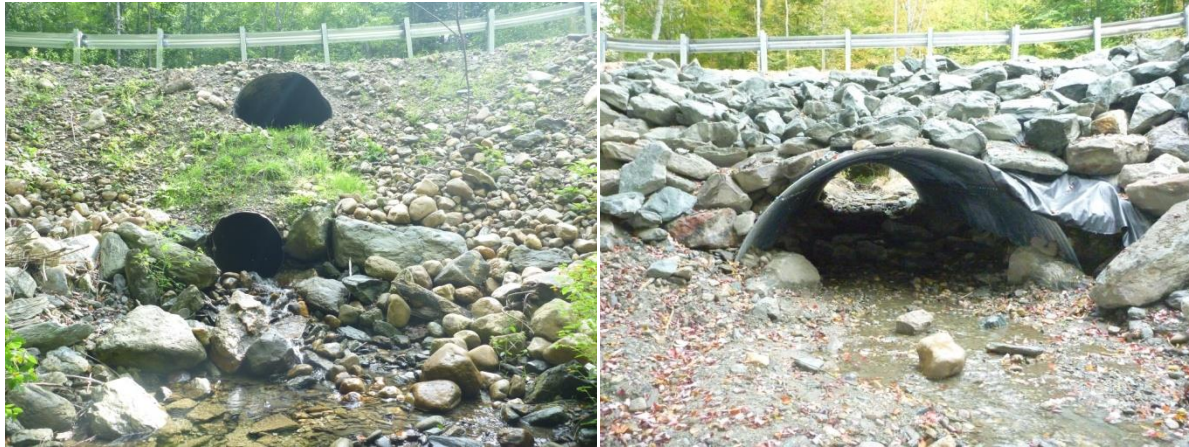
Left: A view of the Marsh Brook culvert outlet on North Hollow road showing two undersized culverts with minimal fish or aquatic organism passage. **Right:** New Marsh Brook culvert at the North Hollow road crossing designed for fish and aquatic organism passage as well as flood resiliency.

Problems / history: Multiple culverts in Rochester Vermont were in need of emergency repair following the flooding from tropical storm Irene in August of 2011. Following tropical storm Irene many of the emergency fixes were designed to quickly open roads for vehicle traffic, but not always allow for fish and aquatic organism passage. Working closely with FEMA and the town of Rochester the US Fish and Wildlife Service has provided technical assistance, engineering designs, and project over site to ensure projects allow both fish and aquatic organism passage.

Site description: Marsh Brook in Rochester Vermont is a headwater tributary to the White River and supports a thriving fishery including Atlantic salmon and a wild brook trout population. This new culvert will allow native brook trout to access the entire headwaters which contain critical thermal refugia and spawning habitat.

Fish and AOP Passage: Before culvert replacement began fish biologists from the US Fish and Wildlife Service captured and marked fish downstream from the culvert with a fin clip. Just three weeks after the new culvert was installed biologists returned and found that over half of the brook trout collected in the first 100ft upstream from the culvert had a fin clip showing that they had passed through the culvert.

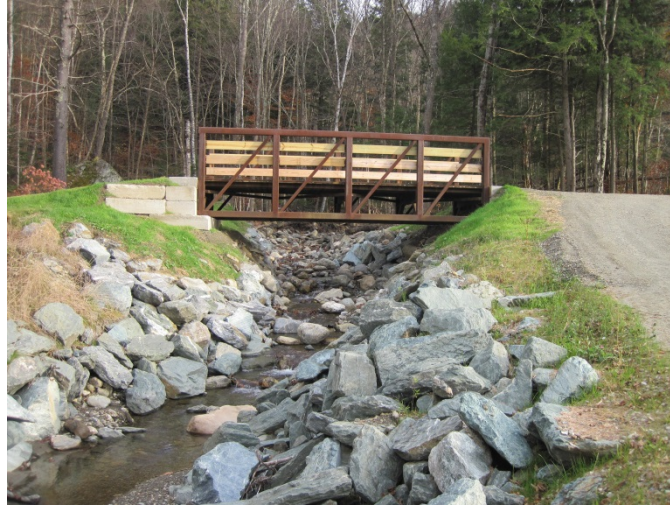
After

Left: A view of the Nason Brook culvert outlet showing the damage from TS Irene. **Right:** Nason Brook Bridge allowing for aquatic organism passage and flood resiliency.

Site description: Nason Brook in Rochester Vermont is a headwater tributary to the White River and supports a thriving fishery including Atlantic salmon and a wild brook trout population. This new bridge allows native brook trout to access 4 miles of critical thermal refugia and spawning habitat.
