## 2019 Final Report

**Project Title:** Bowman Creek Eastern Brook Trout Habitat Restoration, Former Mountain Springs Lake Bottom, South Branch Bowman Creek, Fairmount Township, Luzerne County, PA

**Date Prepared:** March 30, 2020

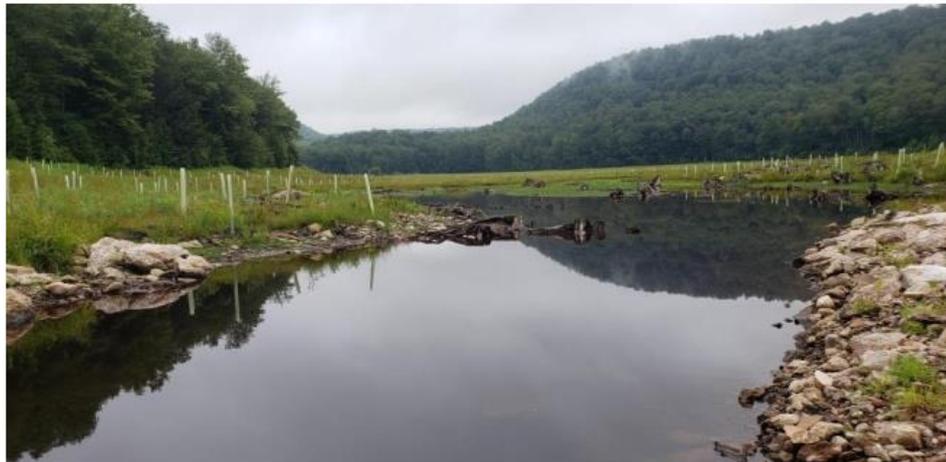
Figure 3 View of former Lake bottom along South Branch Bowman Creek July 22, 2019.

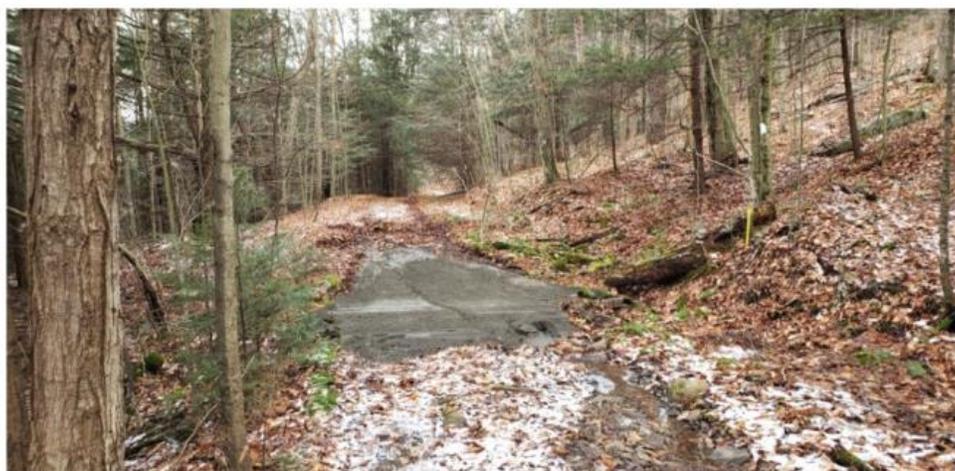
Figure 4 Limestone applications outside of former Lake bottom to increase spring seep pH levels.

Limestone sand applications were applied over 5 locations where spring waters flow from extremely rocky soils outside of the former Lake bottom. The locations will gradually improve alkalinity of the spring flows without loss of the limestone sand to high water events from stream flows. It is anticipated that the limestone will last for long periods of time in improving the pH of the spring waters flowing to the South Branch Bowman Creek. This improvement will be measured over time to evaluate the long term positive impacts from water quality measurements. Placing of limestone sand in the former Lake substrate was not possible due to extreme mud conditions and placing of limestone would be considered as fill in an existing wetland system. Therefore the limestone was placed in upland surroundings outside of the former Lake bottom to infiltrate to the groundwater flows. This fulfills the pH adjustment requirement of the proposed Brook trout improvements for South Branch Bowman Creek. Water quality sampling will continue to evaluate the effectiveness of the treatment. Future electroshock surveys will look for brook trout in comparison to the baseline survey conducted on July 22, 2019.

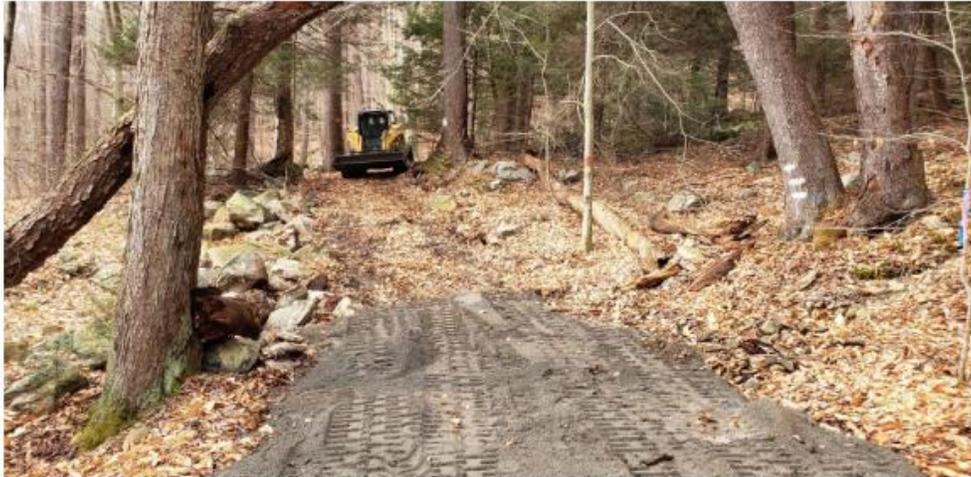
Figure 5 PA Fish and Boat Commission limestone application assistance November 18-19, 2019.

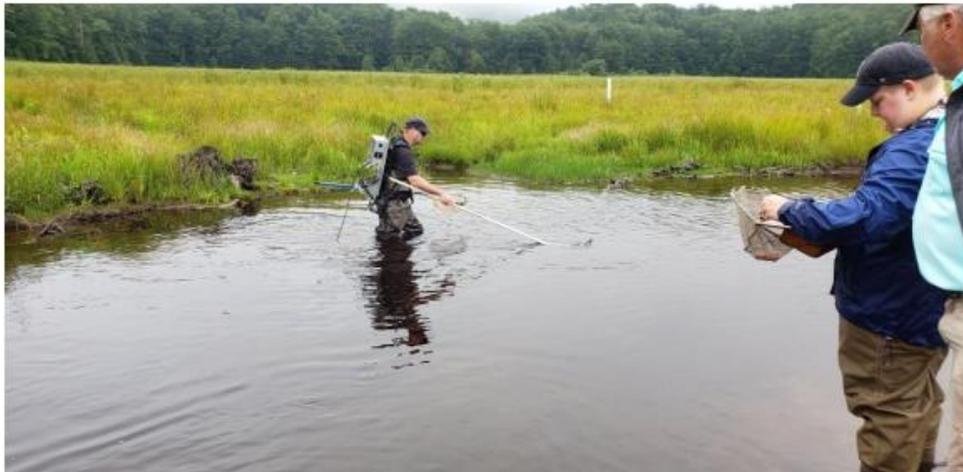
Figure 6 Electroshock sampling of South Branch Bowman Creek in project area July 22, 2019.

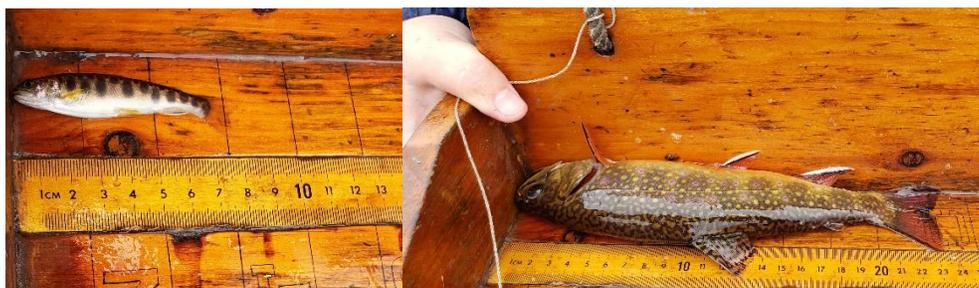
Figure 7 Showing varying age classes from July 22, 2019 sampling.

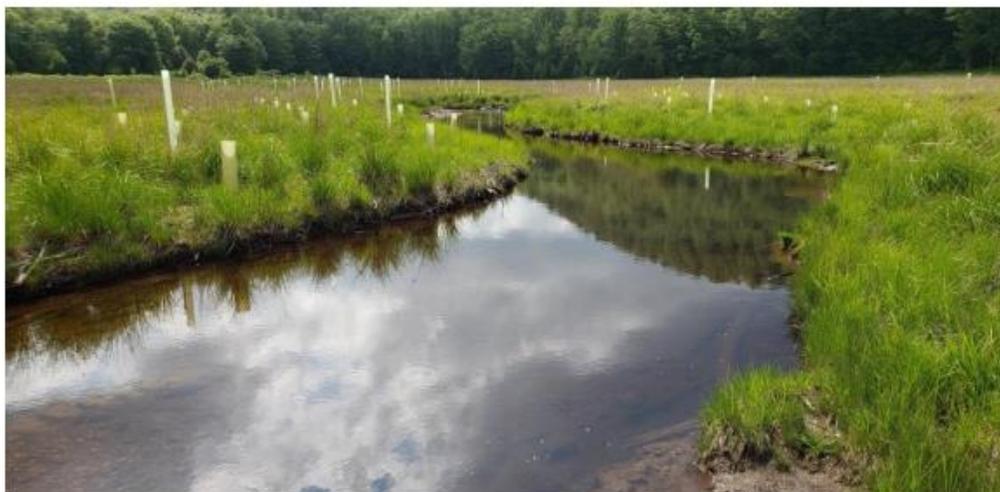
Figure 8 Tree and shrub growth establishing riparian zones as substrate is purged of sediment.
