**2013 Annual Performance Report  
Enhancing Connectivity in the Ash-Black Rock Sub-basin of the West Branch  
Narraguagus River. Project Number 53371-2010-358.**

This 2013 Annual Performance Report summarizes the activities conducted at The Nature Conservancy's Spring River Preserve in T10 and T16, Hancock County, Maine, through our Eastern Brook Trout Joint Venture (Project # 53371-2010-358).

**Project Objective:** TNC and Service will work to replace two degraded stream/road crossings with bankfull channel width spanning open bottom structures (Cooperative Agreement 2011)(Figure 2). *To date, we have surpassed our project objective by installing two open bottom structures and replacing two traditional culverts with bridges.*

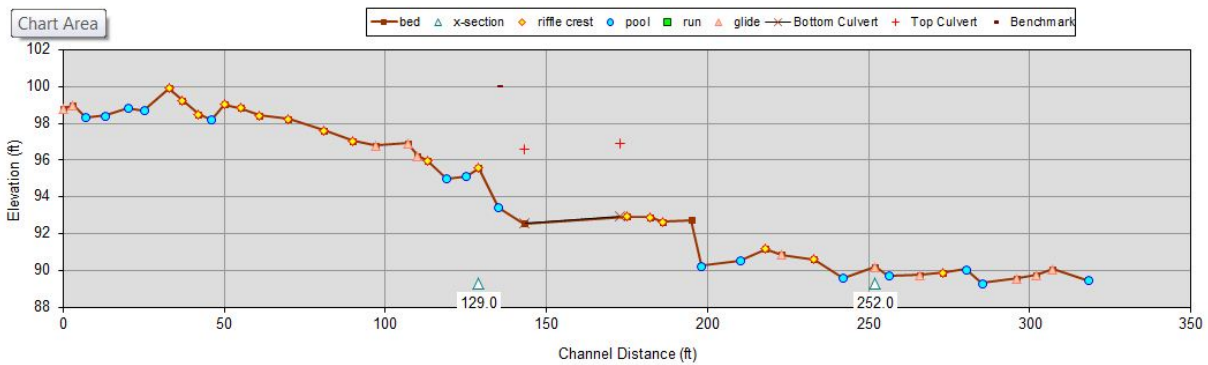
Figure 2: Stream elevations at Site 128 at Spring River Preserve.

In 2013, we anticipated replacing one final culvert with a bridge at Site 128 (UTM 570925; 4945324)(Figure 1). The timing of receiving the elevation data and other field season priorities didn't allow for permitting before the construction window closed. The intention is to complete the final bridge during the 2014 construction window. Elevation data was collected in August 2013 by USFWS (Figure 2).

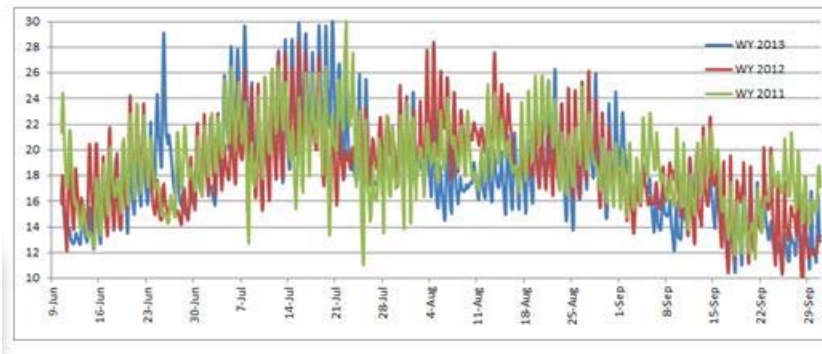
Figure 3: Comparison of yearly stream temperature data at Site 127, 2011 – 2013.

Scott Craig, USFWS, downloaded the data logger at the smaller of the two arch culvert locations in May and December 2013 (Table 1). Water temperatures post-construction are lower despite similar air and precipitation numbers between 2011 and 2012. A hot, dry spell from July 13 – 20, 2013, pushed the summer maximum temperatures up in 2013, but overall, the trend is favorable for lower stream temperatures (Figure 3).

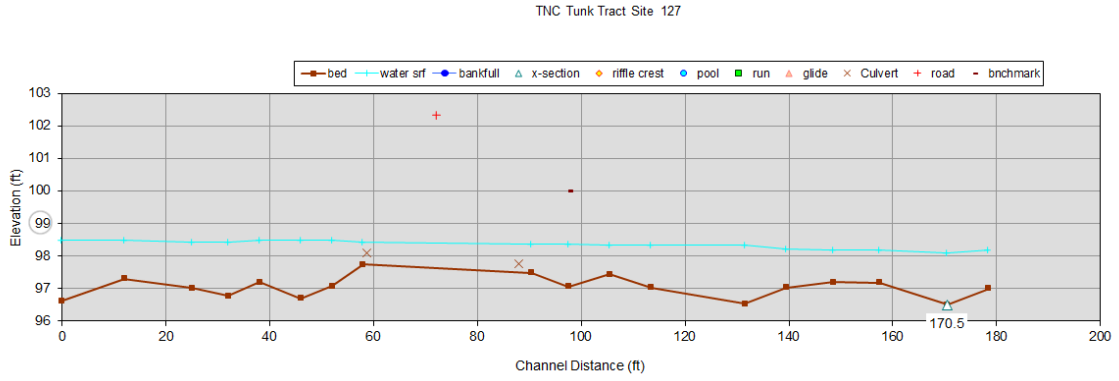
Figure 5: Stream elevations for culvert 127 at Spring River Preserve.

Stream elevations, stream profiles, and road elevation data were collected by Scott Craig in late September 2012 in preparation for construction. Stream data is presented in Figures 5 – 9; stream profile data is unavailable for Culvert 133 due to constraints on the location.

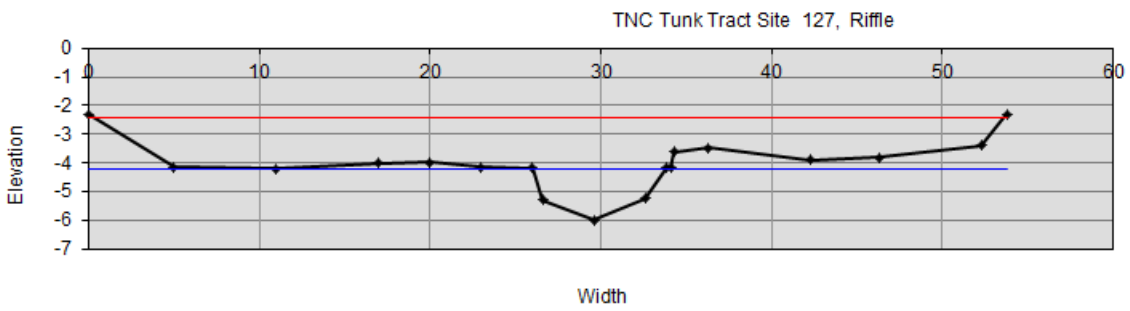
Figure 6: Stream profile for culvert 127 at Spring River Preserve.

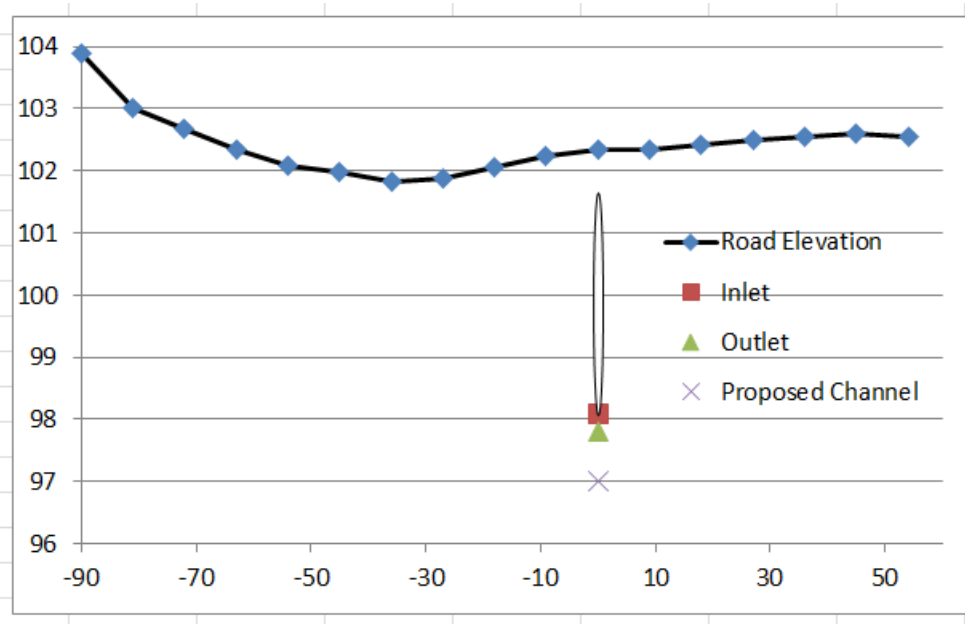
Figure 7: Road profile at site 127 at Spring River Preserve.

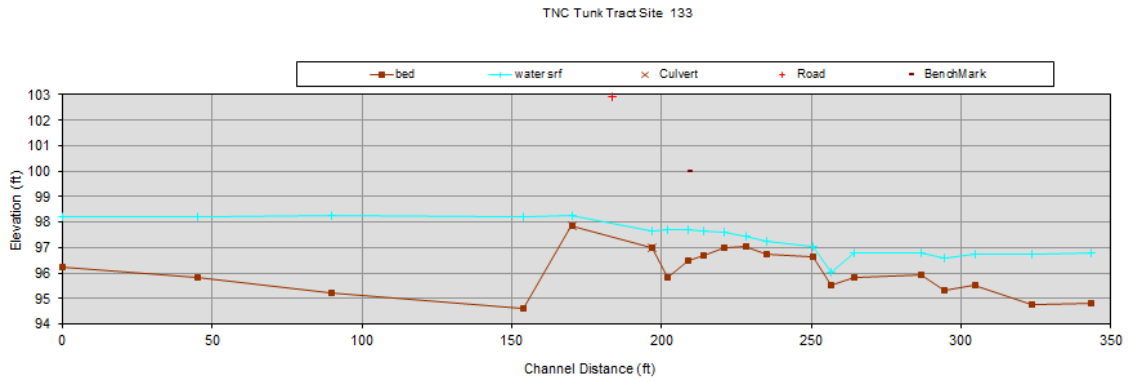
Figure 8: Stream elevation data for site 133 at Spring River Preserve.

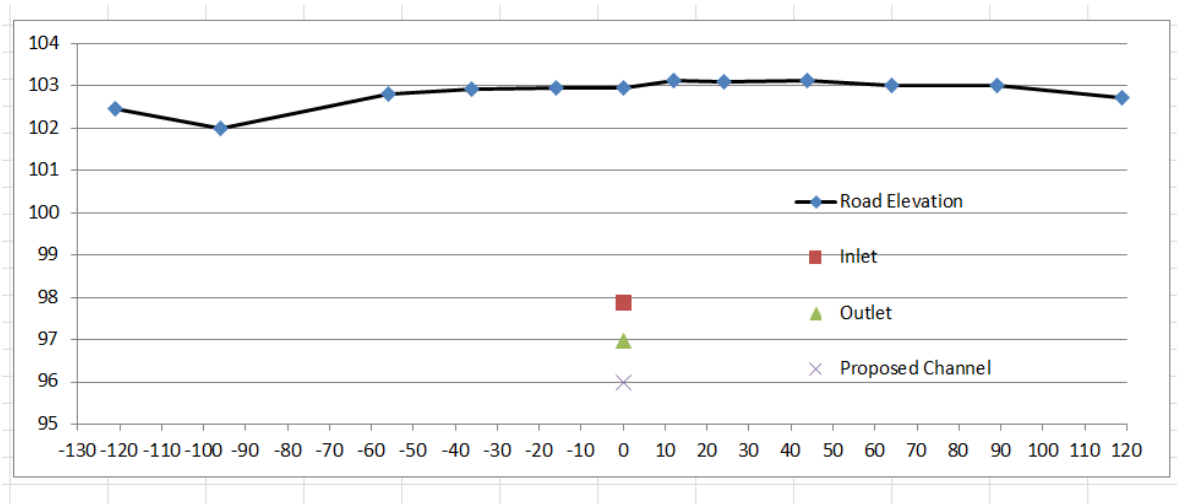
Figure 9: Road elevation for site 133 at Spring River Preserve

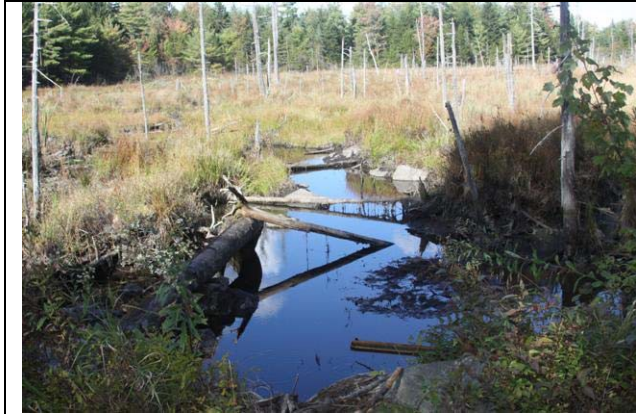
Figure 10; Before - upstream from site 127

TNC contracted with Hanscom Construction for the construction of the two bridges which were built in October 2012 (Figures 10 – 21; Before photos by Scott Craig, USFWS; After photos by Nancy Sferra, TNC).

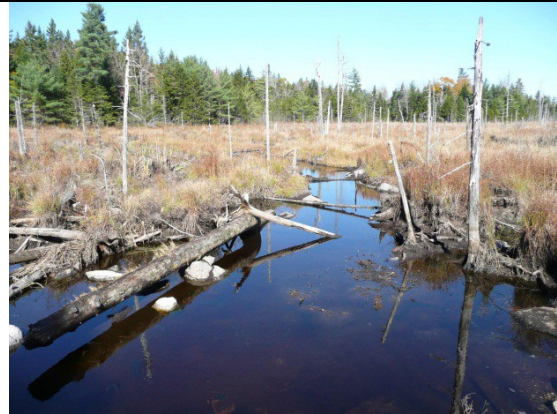
Figure 11: After - upstream from site 127.

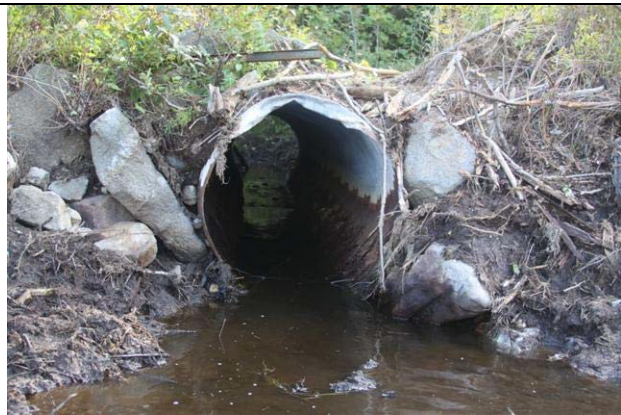
Figure 12: Before - inlet at site 127.

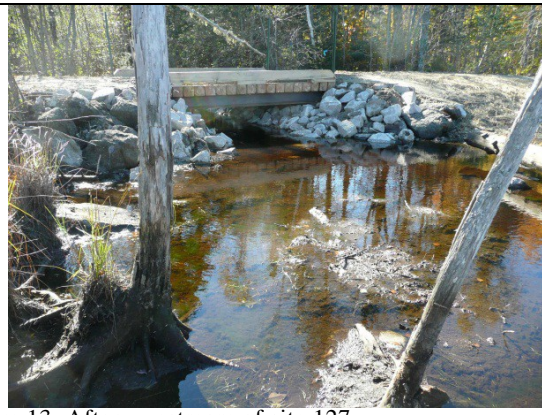
Figure 13: After - upstream of site 127.

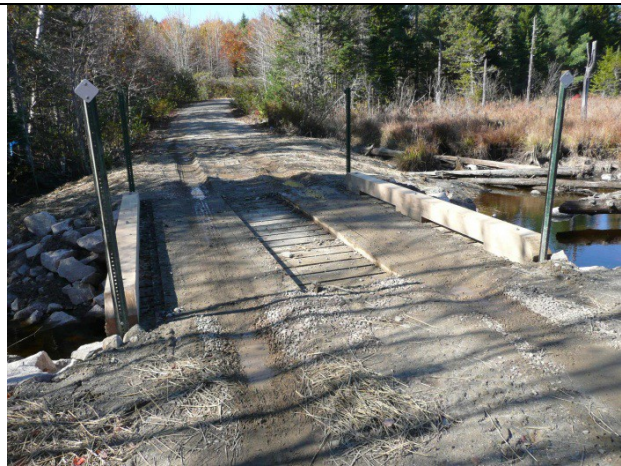
Figure 14: Bridge at site 127.

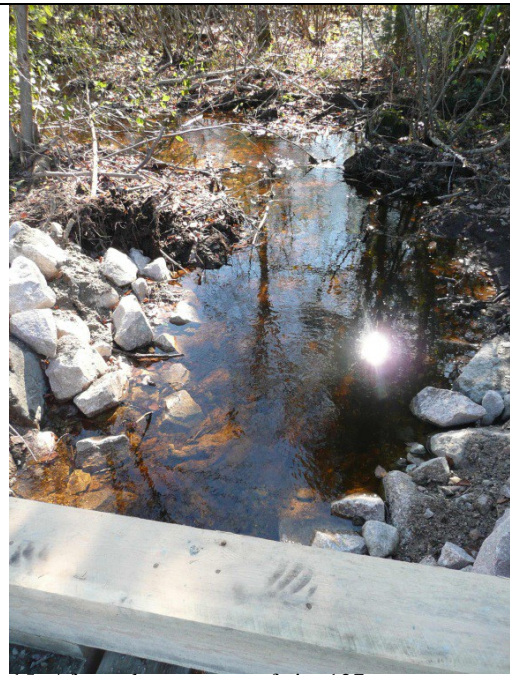
Figure 15: After - downstream of site 127

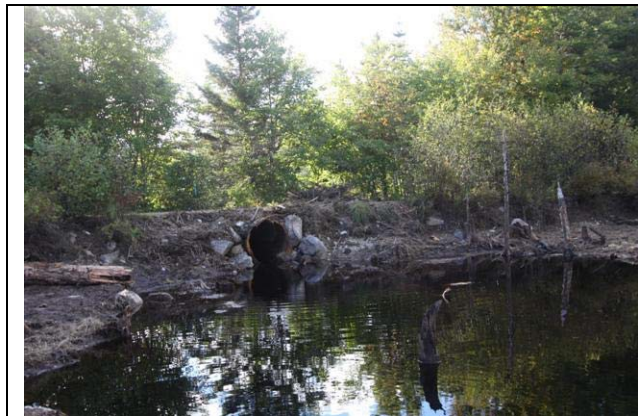
Figure 16: Before - Upstream of site 133.

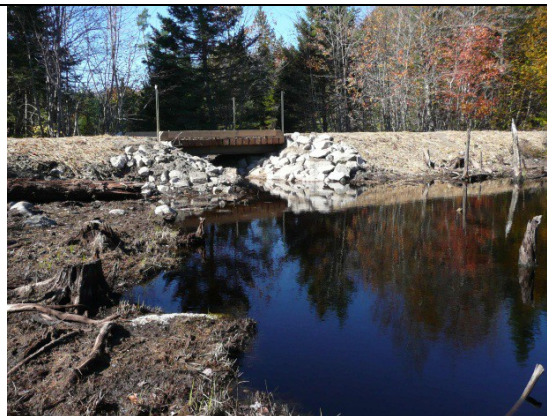
Figure 17: After - upstream of site 133.

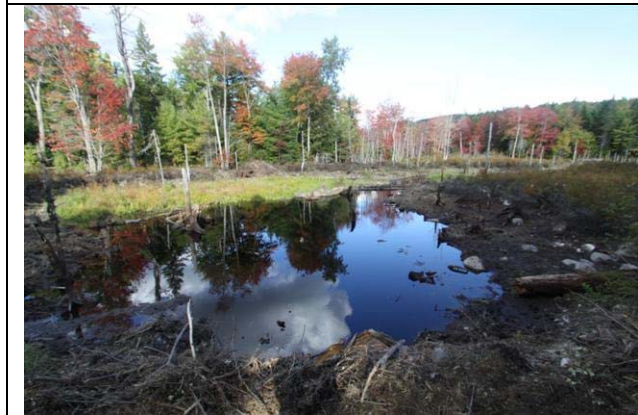
Figure 18: Before - Upstream of site 133.

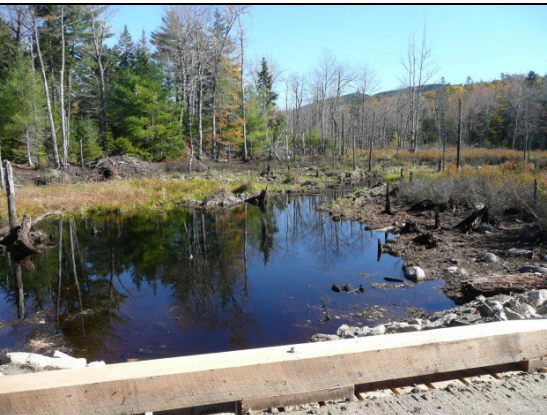
Figure 19: After - Upstream of site 133.

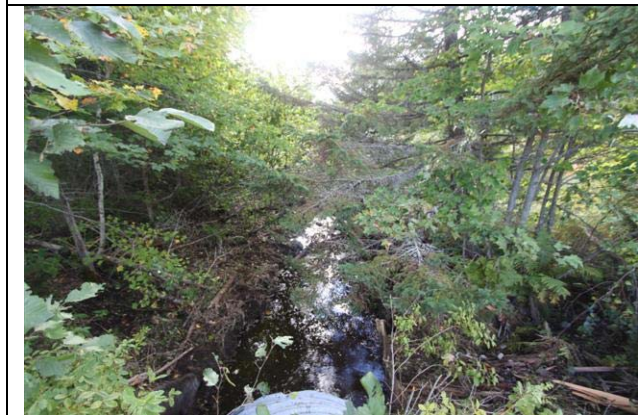
Figure 20: Before - Downstream of site 133.

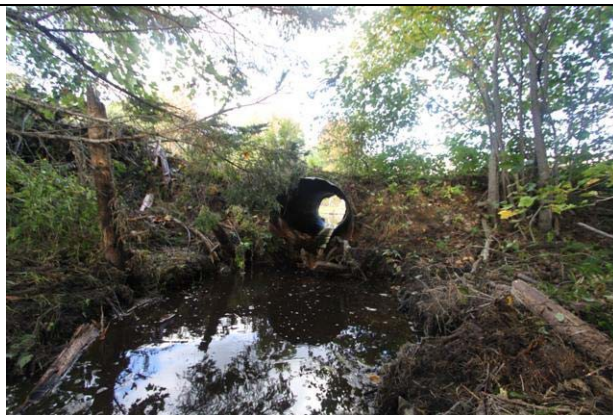
Figure 21: Before - Downstream of site 133.

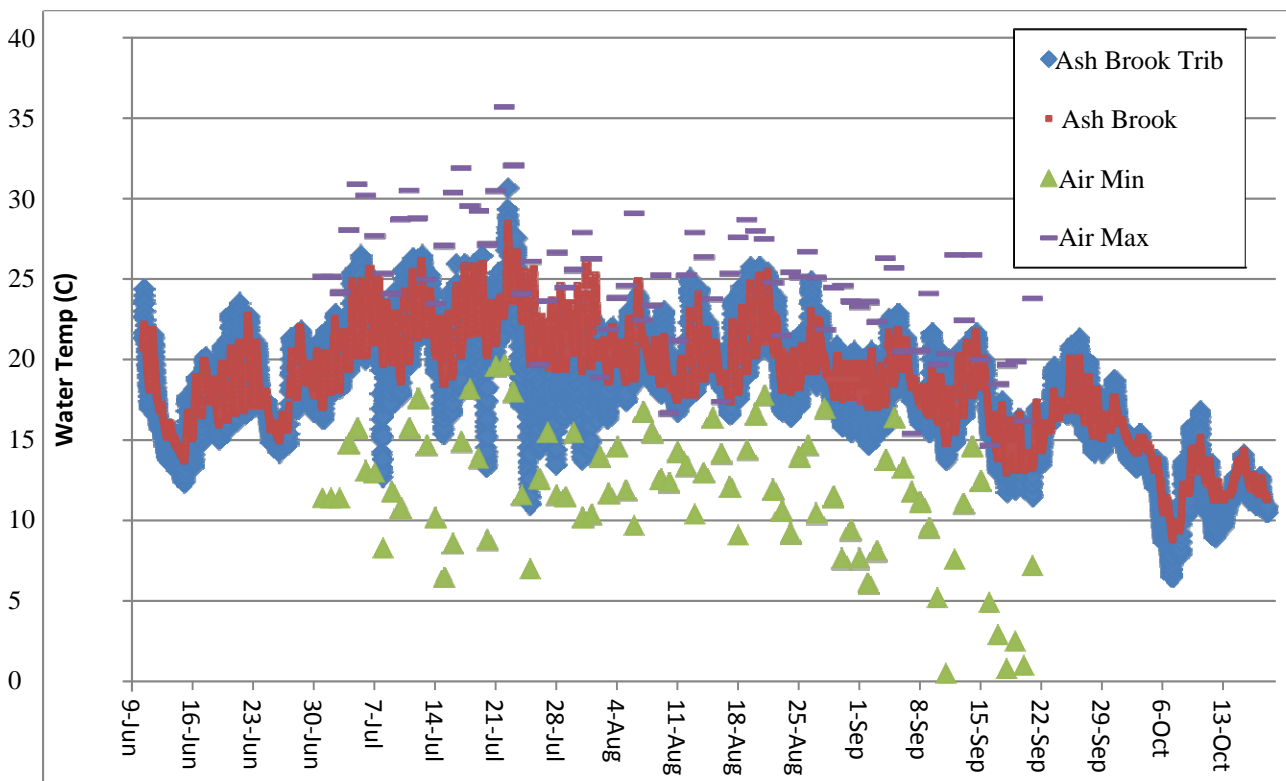
Figure 23: Instantaneous water temperature at the two locations and daily air (max.-min) temperature.

Water temperature data and summary was provided by Scott Craig, US Fish and Wildlife Service. Maximum water temperature in 2011 coincided with the day of maximum air temperature (obtained at the Old Stream USGS stream gage). Maximum water temperature occurred on July 22 when the air temperature reached 35.7 °C. The tributary high temperature was 30.7 °C and the mainstem 28.5 °C. Mean water temperature throughout the summer (June 15 to August 31) at the tributary was 19.8 °C and the mainstem 20.5 °C.

Combined warm water temperatures and low pH (<4.5) appear to limit aquatic fauna in these two streams. Specifically, high water temperatures (>24°C) reflect potential impediments to sustained brook trout residence.

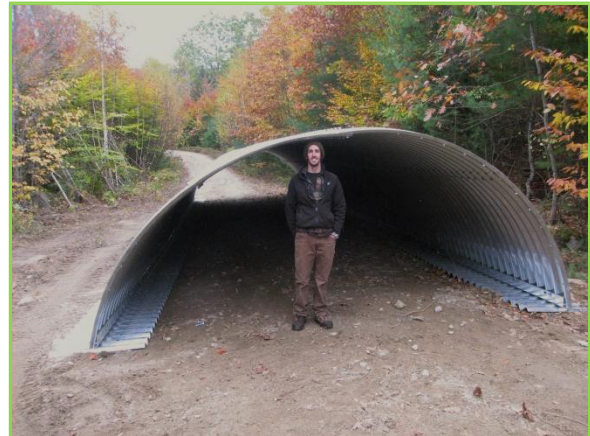
Figure 25: Ash Bog Stream culvert. Photo by Dan Grenier.

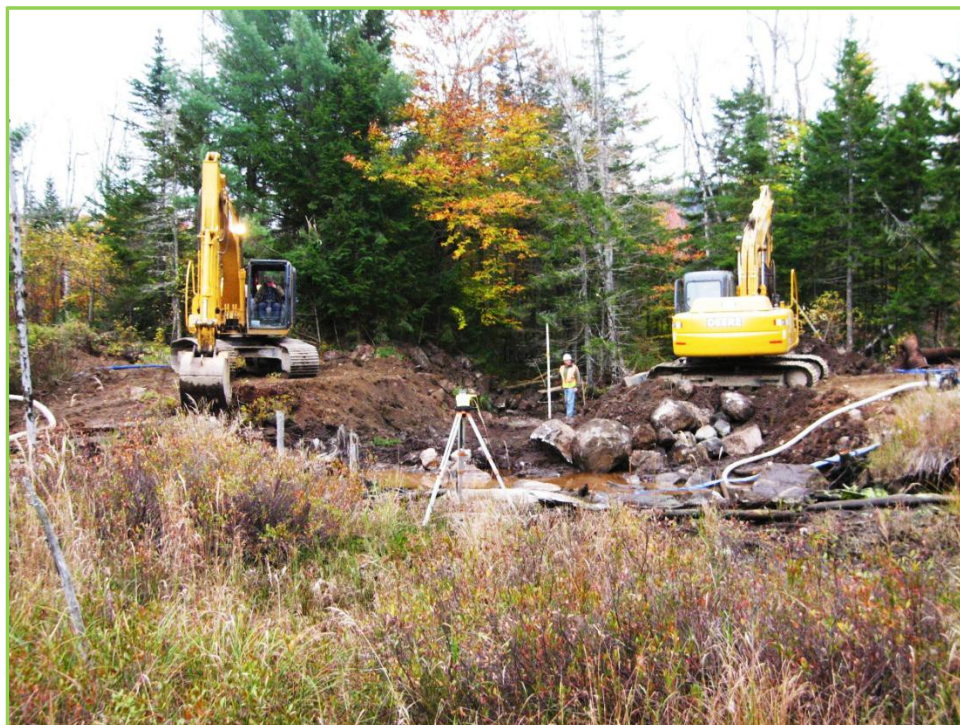
Figure 26: Construction work at Black Rock Brook site, October 2011. Photo by Dan Grenier.

Gravel fill for the project was obtained on-site from previously retired logging roads near the construction sites. Gravel from the road surface was scraped to the natural substrate and trucked to the construction site. Bedrock beneath the Black Rock Brook culvert created some challenges in the installation of that culvert but they were able to break apart the bedrock with the equipment on hand without having to elevate the culvert. Construction took two days at each site.

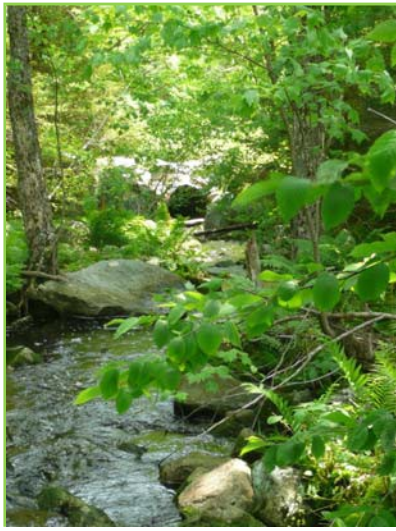
Figure 27: Ash Bog Stream downstream section before culvert replacement. Photo by Nancy Sferra.

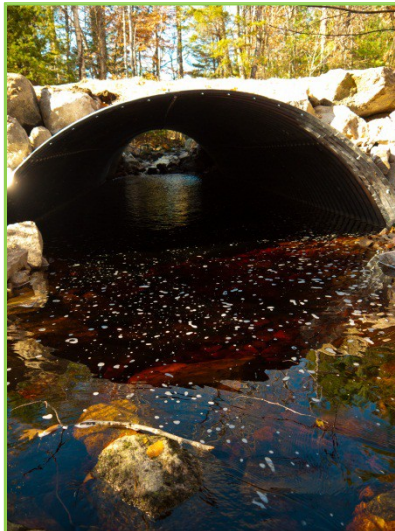
Results: No changes were observed at Ash Bog Stream following construction. The stream flow was relatively unchanged due to the volume of water still flowing through the culvert at the time of construction. However, the new bottom arch culvert will allow for unrestricted fish passage in all seasons. The sedge meadow above the Black Rock Brook culvert is significantly changed due to the culvert. The restriction created by the road surface and undersized culvert has been eliminated and the standing water upstream of the culvert has drained out. There is a clear thread of the stream in the sedge meadow with sections of exposed mud flat where there had been pooled water. It is likely that the reforestation of the sedge meadow can be accelerated through tree planting in the spring – northern white cedar and black and red spruce will likely do the best in the restoration area until the site can be colonized by red maple. Additionally, 2011 was an exceptional seed year for white cedar and spruce, both of which are abundant along the wetland edge. There may be some natural regeneration on the mud flats from seed drift of the fringing forest.

Figure 28: Ash Bog Stream culvert outlet following construction. Photo by Nancy Sferra.

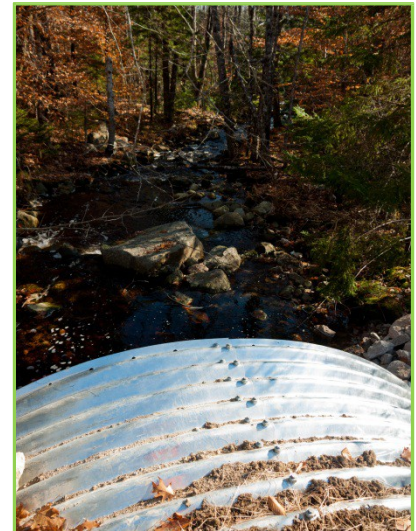
Figure 29: Ash Bog Stream downstream of new culvert outlet. Photo by Nancy Sferra.

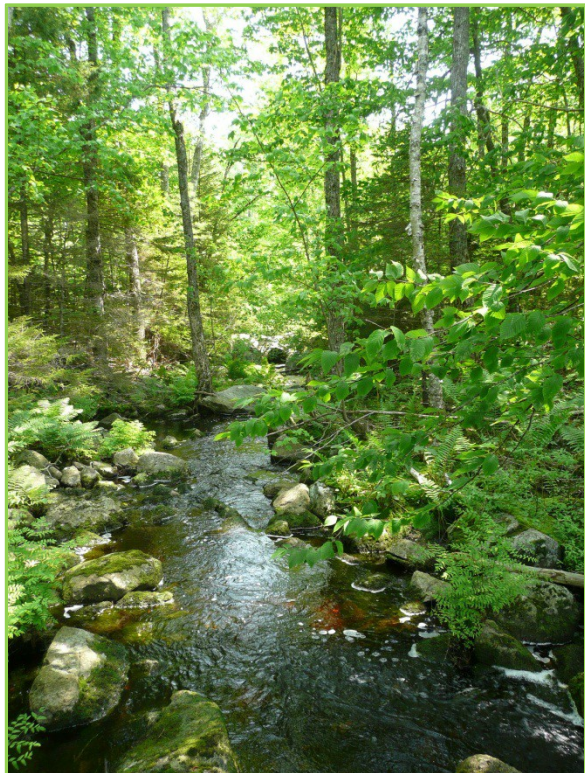
Figure 30: Ash Bog Stream upstream of culvert prior to construction.  
Photo by Nancy Sferra.

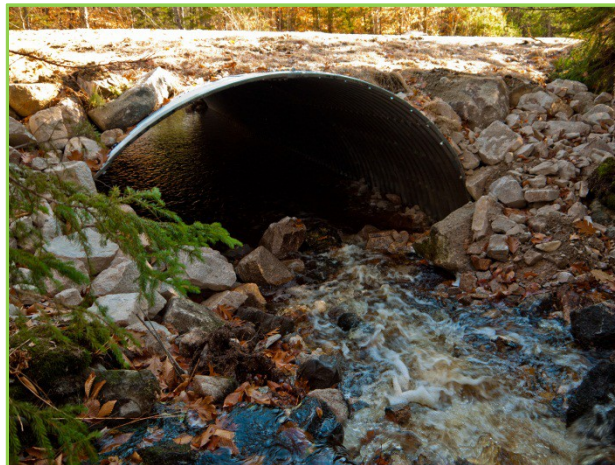
Figure 31: Ash Bog Stream upstream of culvert following installation of new culvert. Photo by Nancy Sferra.

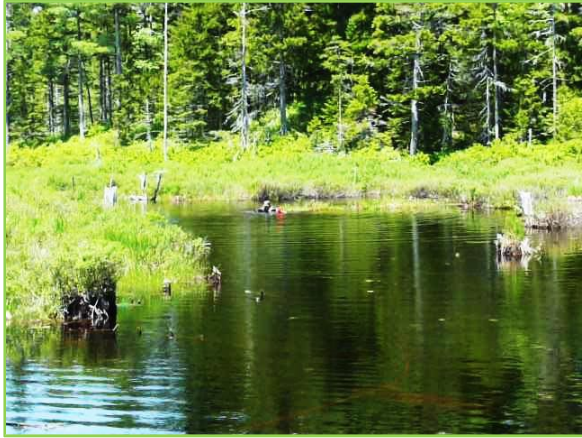
Figure 32: Black Rock Brook upstream before construction. Photo by Nancy Sferra.

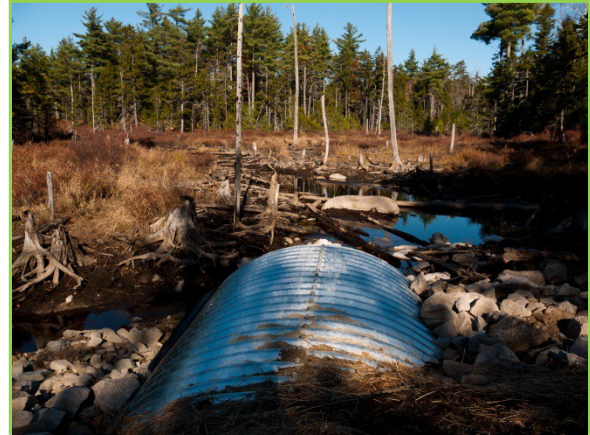
Figure 33: Black Rock Brook downstream following installation of new culvert. Photo by Nancy Sferra.

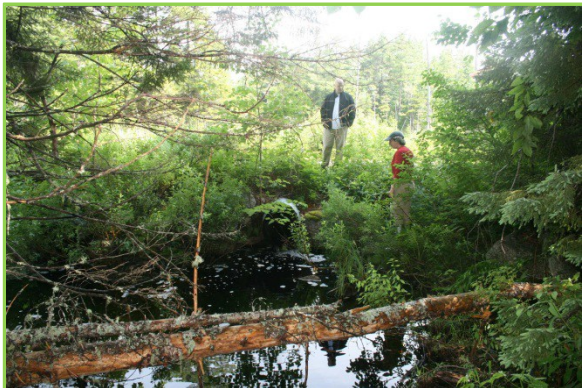
Figure 34: Black Rock Brook upstream of culvert before restoration. Photo by Scott Craig.

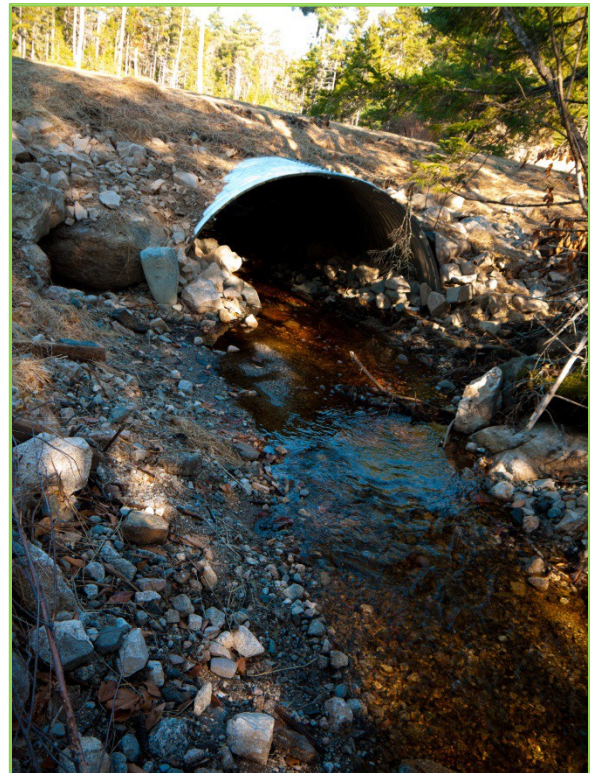
Figure 35: Black Rock Brook downstream following culvert installation. Photo by Nancy Sferra.

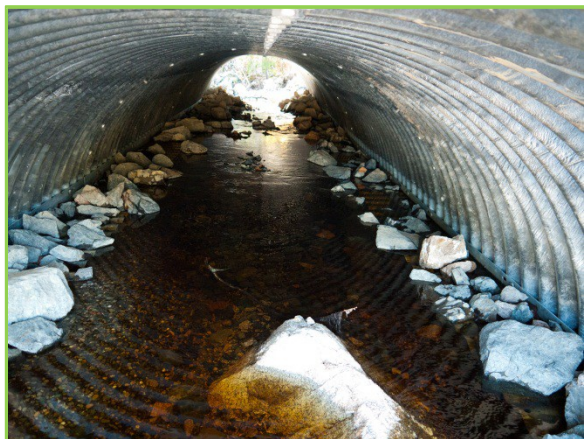
Figure 36: Black Rock Brook culvert looking from the upstream side. Photo by Nancy Sferra.

Culverts were purchased from ConTech. In order to minimize the amount of fill required at the Black Rock Stream culvert, a compressed half pipe was used. A 9 foot span, 3’ 11’ high was used at Black Rock Brook. A 15 foot span, 6’ 7” high was used at Ash Bog Stream. Both culverts utilized steel footing pads. The engineering work was done prior to the execution of the Cooperative Agreement and the cost of this activity is not included in the financial report.

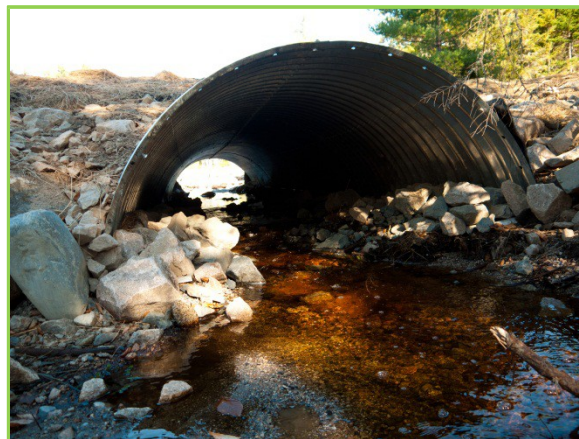
Figure 37: Black Rock Brook culvert looking from the downstream side. Photo by Nancy Sferra.
